SOI Pixel Development at KEK

Sep. 26, 2008 @Pixel 2008

Yasuo Arai (KEK)

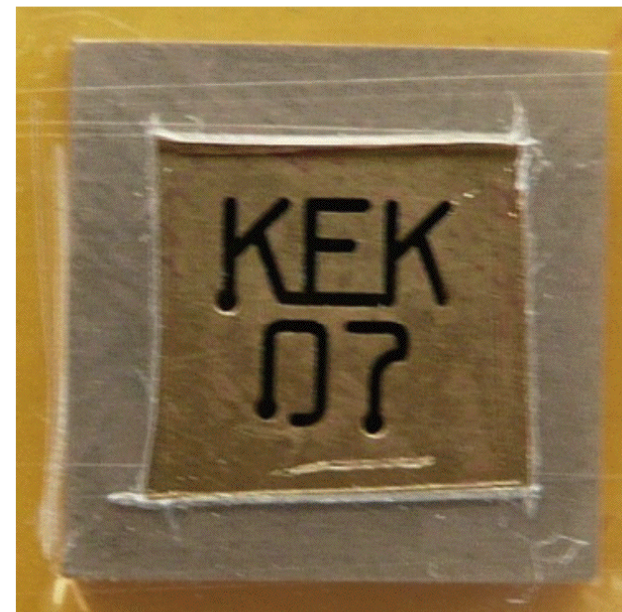
INTPIX2

$V_{det}=1.5V$
800 μs Integration Time

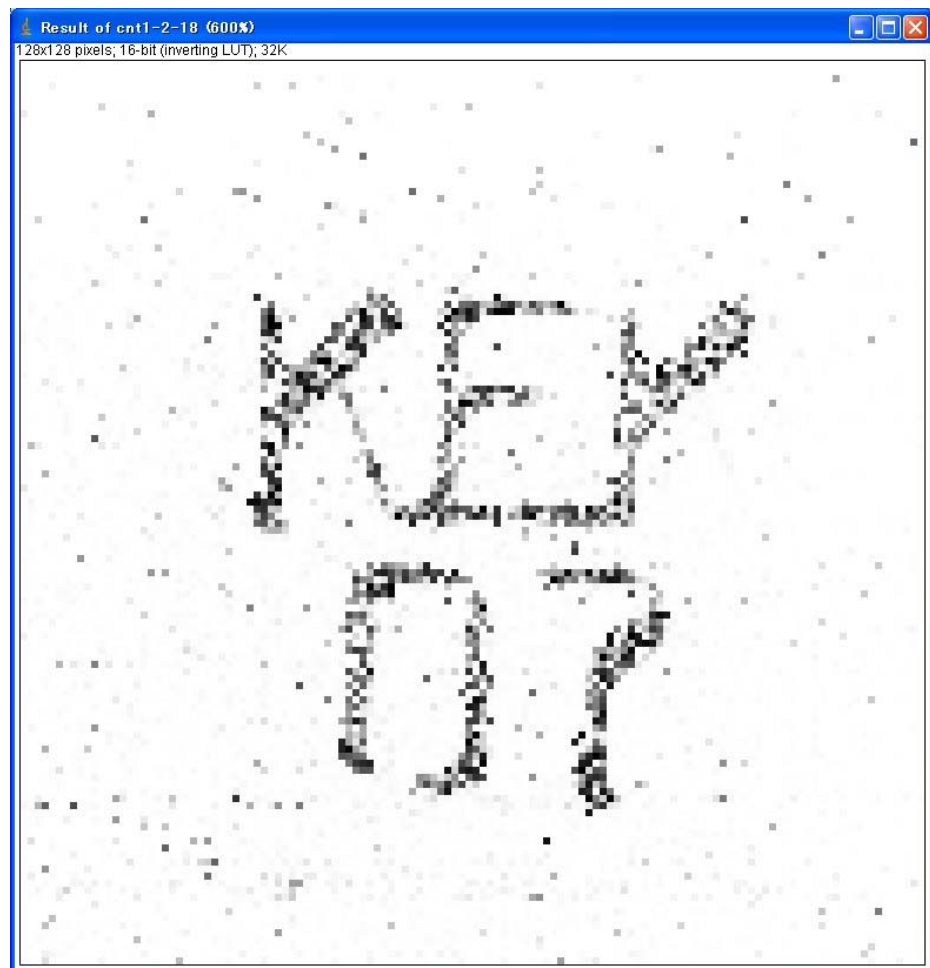
CNTPIX2

Position resolution (pixel size= $60\mu\text{m} \times 60\mu\text{m}$)

$V_{\text{det}}=1.5\text{V}$
1.6 ms Integration Time
